TEST REPORT

Reference No. : SZ2021110613-1R2E

Name of Product : Waterproof beach bag

Requirement:
IPX6, IEC 60529:1989+A1:1999+A2:2013

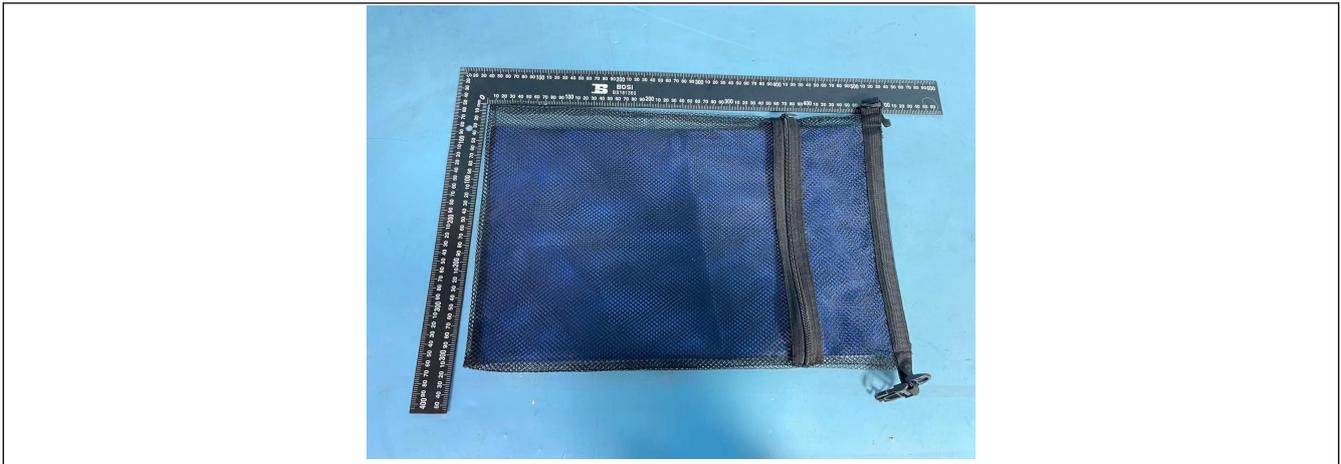
Sample Received:

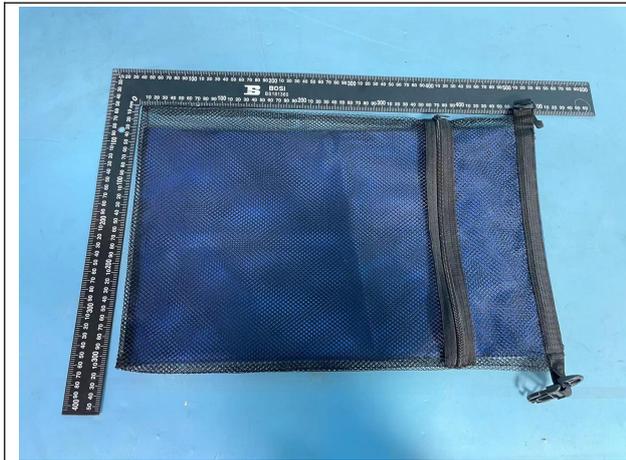
SZ2021110613-1 before test

Sample No.	Appearance
SZ2021110613-1	No visible defect

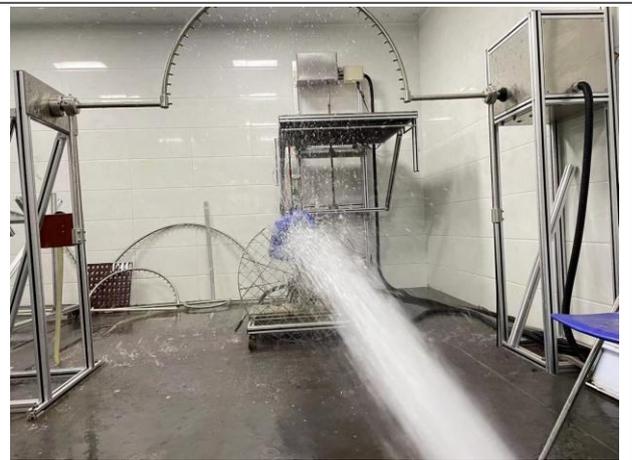
SZ2021110613-1 during test

- internal diameter of the nozzle: 12,5 mm;
- delivery rate: 100 l/min \pm 5 %;
- water pressure: to be adjusted to achieve the specified delivery rate;
- core of the substantial stream: circle of approximately 120 mm diameter at 2,5 m distance from nozzle;
- test duration per square metre of enclosure surface area likely to be sprayed: 1 min;
- minimum test duration: 3 min;
- distance from nozzle to enclosure surface: between 2,5 m and 3 m.

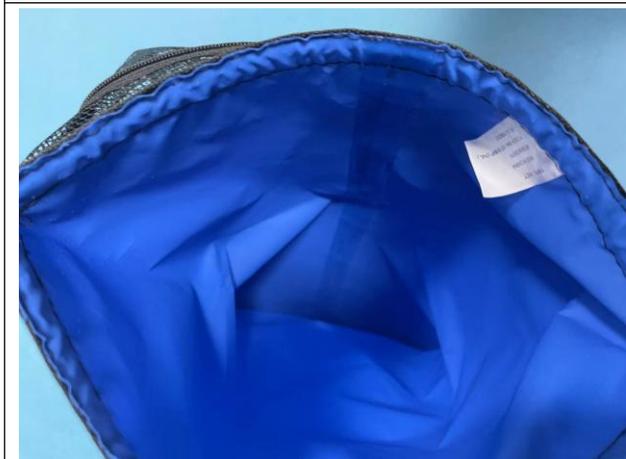
SZ2021110613-1 after test

Sample No.	Test Result	Conclusion
SZ2021110613-1	No ingress of water is observable inside the Waterproof beach bag.	P
