TEST REPORT

Report No...... : WTF22F04079772F
Applicant..... : Mid Ocean Brands B.V.
Address..... : 7/F., Kings Tower, 111 King Lam Street, Cheung Sha
Wan, Kowloon, Hong Kong
Manufacturer..... : 115649
Sample Name..... : Sublimation mug with spoon
Model No...... : MO6581
Test Requested..... : In accordance with Council of Europe Resolution
84/500/EC (2005/31/EC) and Regulation (EC) No
1935/2004.
Test Conclusion..... : **Pass** (Please refer to next pages for details)
Date of Receipt sample..... : 2022-04-25
Testing period..... : 2022-04-25 to 2022-04-29
Date of Issue..... : 2022-04-29
Test Result..... : Refer to next page (s)

Test Results:
Extractable Lead and Cadmium Content

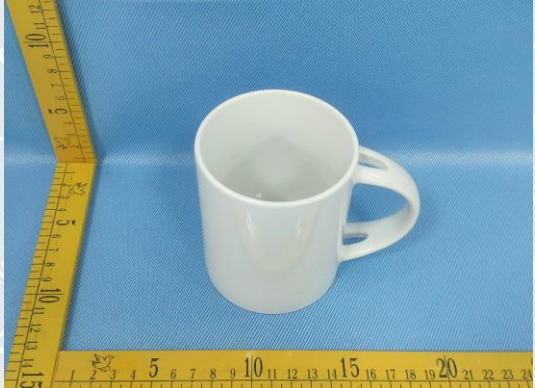
No.	Photo of testing part	Parts Description	Client Claimed Material
1

White ceramic	Ceramic

Test Items	Result (mg/L)	LOQ (mg/L)	Limit (mg/L)
	No.1		
Extractable Lead	ND	0.1	4.0
Extractable Cadmium	ND	0.01	0.3

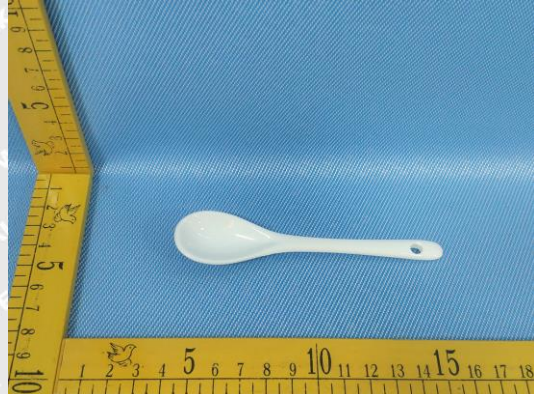
No.	Photo of testing part	Parts Description	Client Claimed Material
2

White ceramic	Ceramic

Test Items	Result (mg/dm ²)	LOQ (mg/dm ²)	Limit (mg/dm ²)
	No.2		
Extractable Lead	ND	0.1	0.8
Extractable Cadmium	ND	0.01	0.07
