Report No.: SZ2023060848-1E

Name of Product :	Waterproof smart phone pouch with cord.		
Trade mark :	-		
Model :	MO8782		
Ratings :	-		
Supplier :	107961		
Sample Received :	Jun. 20, 2020		
Amount of samples	2 pcs		
received :			
Test Period :	Jun. 21, 2020		
Test Specification and Conclusion:

IPX8, IEC 60529:1989+A1:1999+A2:2013

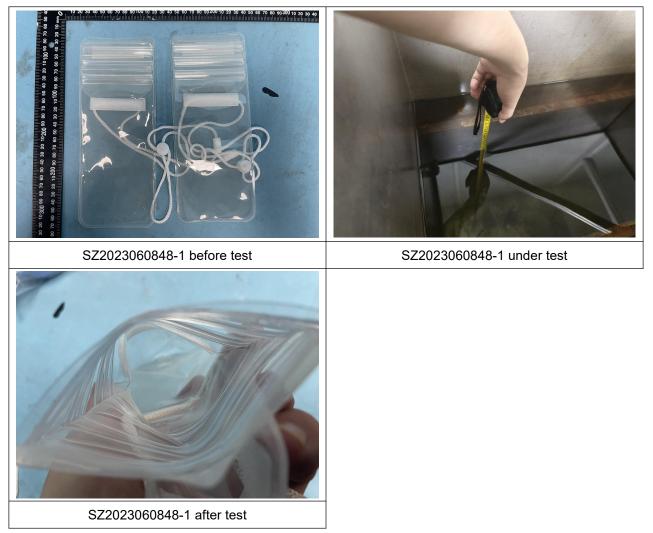
### 1.9. TEST PHOTOS

As the client required the pouch is located 1000 mm below the surface of the water

Sample No.	Test Result	Conclusion
SZ2023060848-1	No ingress of water is observable inside the	Р
	Waterproof Pouch	'
