# TEST REPORT

**Report No.**..... : WTF23F03063585T  
**Applicant**..... : Mid Ocean Brands B.V.  
**Address**..... : 7/F., Kings Tower, 111 King Lam Street, Cheung Sha  
Wan, Kowloon, Hong Kong  
**Manufacturer**..... : 111025  
**Sample Name**..... : Set of 2 double wall espresso glasses, Double wall glass  
with bamboo lid 350 ml  
**Model No.**..... : MO9709, MO9720  
**Test Requested**..... : In accordance with Council of Europe Resolution  
84/500/EC, Council of Europe Resolution AP(2002)1,  
(2005/31/EC), Council of Europe Resolution AP(2004)5  
and Regulation (EC) No 1935/2004.  
**Test Conclusion**..... : **Pass** (Please refer to next pages for details)  
**Date of Receipt sample**..... : 2023-03-28  
**Testing period**..... : 2023-03-28 to 2023-04-01  
**Date of Issue**..... : 2023-04-03  
**Test Result**..... : Refer to next page (s)

Report No.: WTF23F03063585T

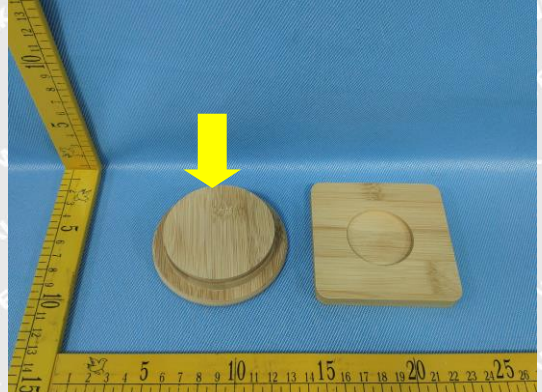
No.	Photo of testing part	Parts Description	Client Claimed Material
2

Primary color wood	Wood
3

Test Item	Result (mg/kg)	LOQ (mg/kg)	Limit (mg/kg)
	No.2		
Pentachlorophenol (PCP)	ND	0.10	0.15

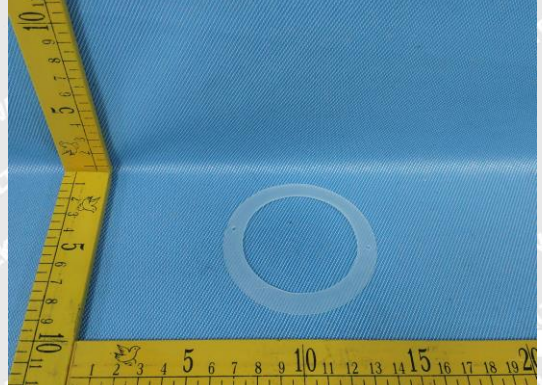
Transparent silicone rubber	Silicone rubber

Food Simulant	Test Condition	Result (mg/kg)	LOQ(mg/kg)	Limit (mg/kg)
		No.3		
3% Acetic Acid	70°C for 2 hours	ND	20	60
50% Ethanol	70°C for 2 hours	ND	20	60

Test Item	Result (mg/kg)	LOQ (mg/kg)	Limit (mg/kg)
	No.3		
Bisphenol A	ND	0.1	Not Detected
